Manhole Inspection Summary

Manhole # S25KK_046MH

Insp Date: **8/27/07 11:30 AM**

Location Address: **2300 MCCULLOH ST**

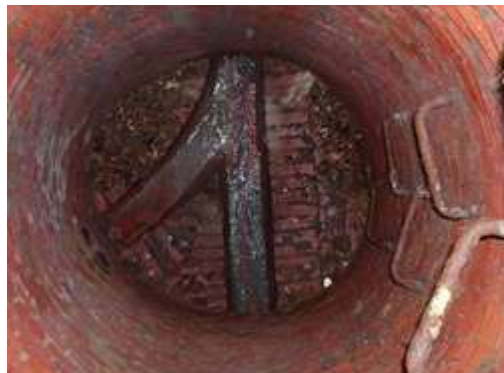
Top View

Corroded steps. Bench debris.

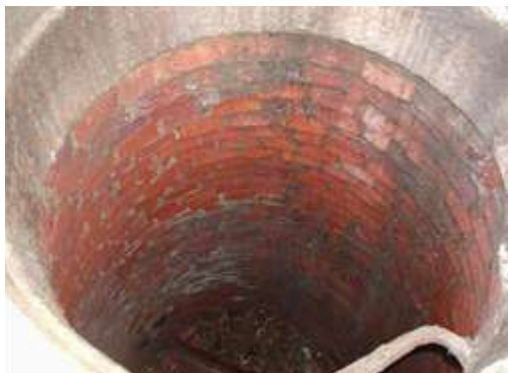
Defect

Frame leaks. Adjustment and Barrel infiltration - other side.

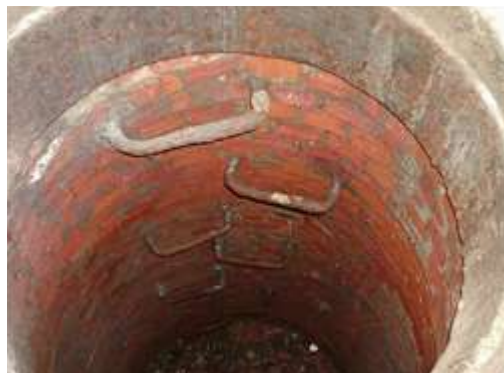
Defect

Frame leaks. Adjustment and Barrel infiltration.

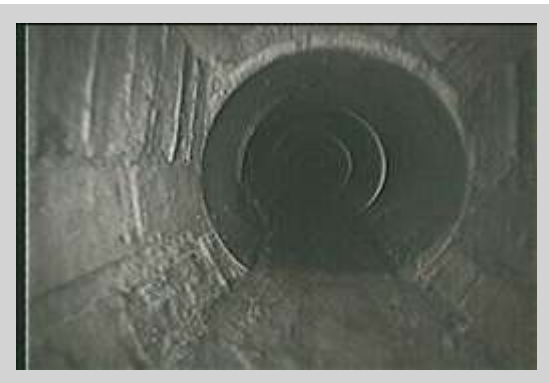
10 in. Circular Gravity Sewer Pipe In @ 6 O'Clock

Infiltration: **Evidence** Pipe Seal Cond: **Cracked**

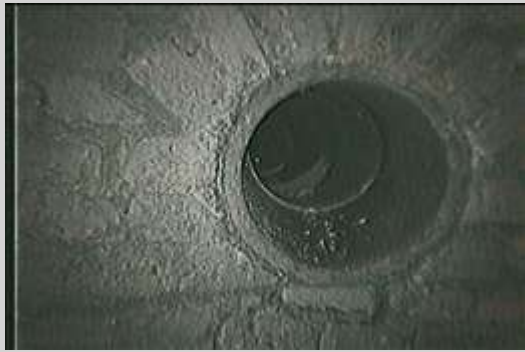
Pipe In @ 8 O'Clock

Infiltration: **Evidence**
